# Manhole Inspection Summary

Manhole # S29M1\_010MH

Insp Date: **3/3/08 8:40 AM**

**Location** Address: **2501 Round Road**

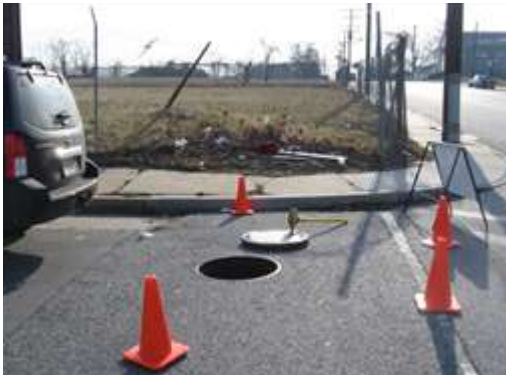
Location View

Round Rd.

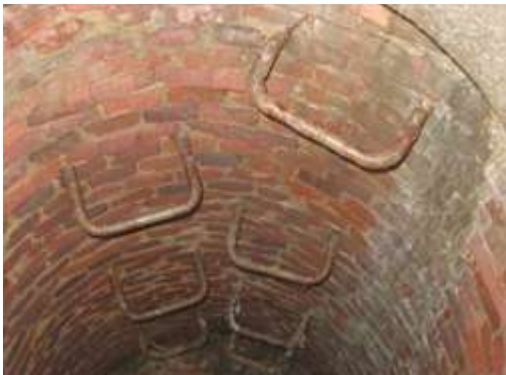
Steps

Count: **7** Missing: **0** ☒ **Corroded**

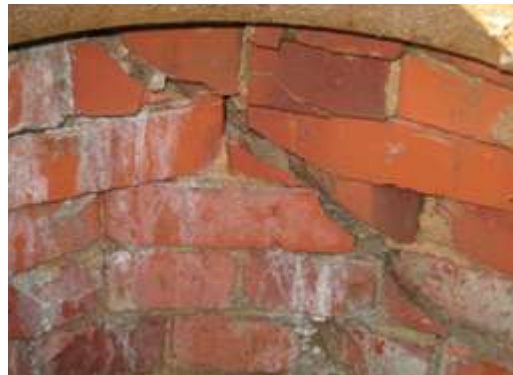
Defect 1

Condition: ☐ Sound ☒ **Cracked** ☐ Root Intrusion ☐ Loose Brick ☐ Deteriorated

Infiltration: ☐ None ☐ Joint ☒ **Cracks** ☐ Mortar ☐ Roots ☒ **Wall**

Chimney (cracked)

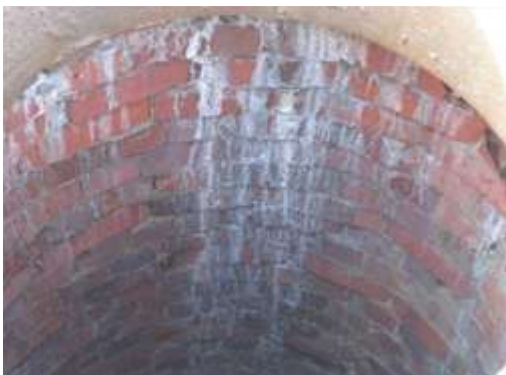
Defect 2

Infiltration: ☐ None ☐ Joint ☐ Cracks ☐ Mortar ☐ Roots ☒ **Wall**

Wall

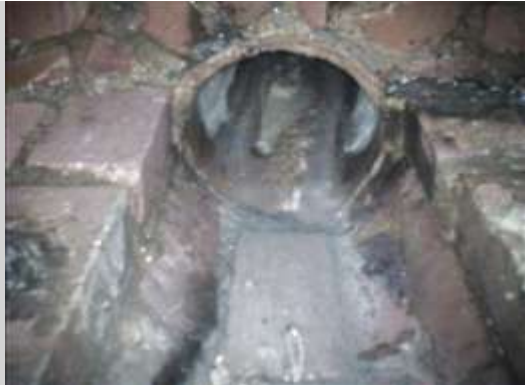
12 O'Clock Outflow

8 in. Circular Gravity Sewer  
Pipe Out @ 12 O'Clock

Pipe Height: **9.6** (in.) Rod and Bar (Angled)  
Pipe Material: **Clay** ☐ Pipe Lined  
Invert Depth: **11.32** (ft.) Flow Characteristics: **Fast**  
Deposits: ☒ None ☐ Mud ☐ Sludge ☐ Debris ☐ Grease  
Silt Depth: (in.) Deposits Extent:  
Infiltration: **None** Pipe Seal Cond: **Sound**

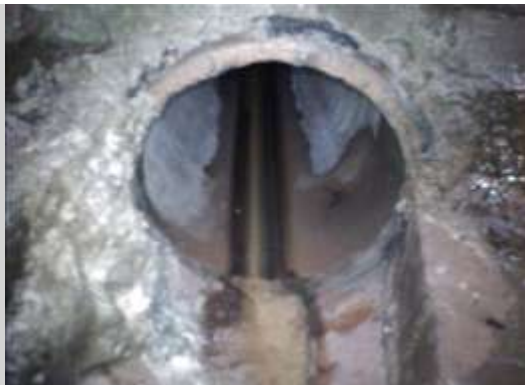
6 O'Clock Inflow

8 in. Circular Gravity Sewer  
Pipe In @ 6 O'Clock

Pipe Height: **9.6** (in.) Rod and Bar (Angled)  
Pipe Material: **Clay** ☐ Pipe Lined  
Invert Depth: **10.68** (ft.) Flow Characteristics: **Fast**  
Deposits: ☒ None ☐ Mud ☐ Sludge ☐ Debris ☐ Grease  
Silt Depth: (in.) Deposits Extent:  
Infiltration: **None** Pipe Seal Cond: **Sound**

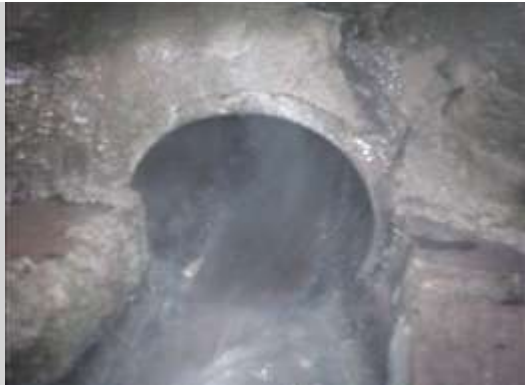
8 O'Clock Inflow

8 in. Circular Gravity Sewer

Pipe In @ 8 O'Clock

Pipe Height: **9.6** (in.) Rod and Bar (Angled)

Infiltration: **None**

Pipe Seal Cond: **Sound**
